Area Structure Plan

ISLAND VIEW BAY MOONLIGHT COVE

Proposed Country Residential Subdivision
Pt. S 1/2 28 - 68 - 13 - W4M
Lakeland County

June 07, 2004
Final Draft

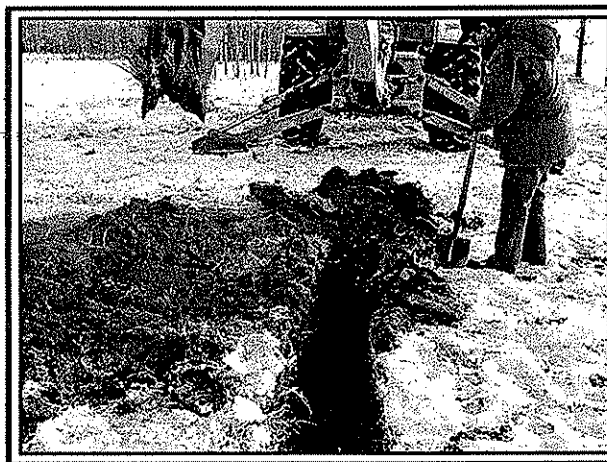
Photograph 2. View to the east showing the length of the first backhoe test.

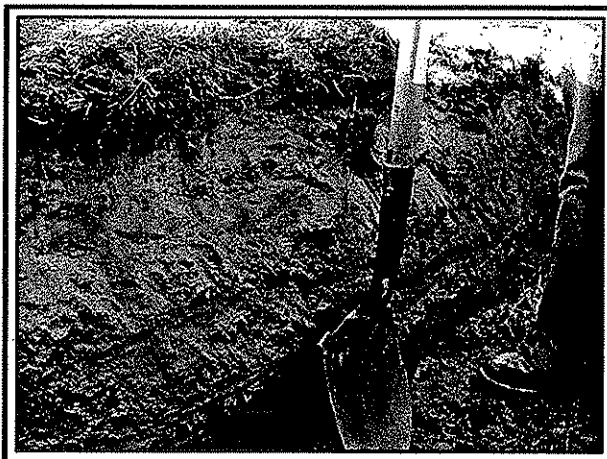
Photograph 6. View of the wall profile of the backhoe test shown in Photograph 3.

A row of backhoe tests were excavated eastward from this first test and GfOx-49 (Photographs 5, 6, 7, 8, and 9). The tests were generally 25 meters apart, with all of the tests positioned approximately 5 to 7 meters from the drop-off to the lake. The tests in this row varied in length from 1.25 meters to 3 meters, and were excavated to a depth of between 0.5 meters and 1 meter. The tests revealed a dark brown humic layer approximately 10 centimeters thick overlying silty sand to approximately 95 centimeters, which is underlain by hard clay.
