# 2018 Water Quality Report

## Lac La Biche Lake - East Basin

Lac La Biche County, Alberta

**December 15, 2018**

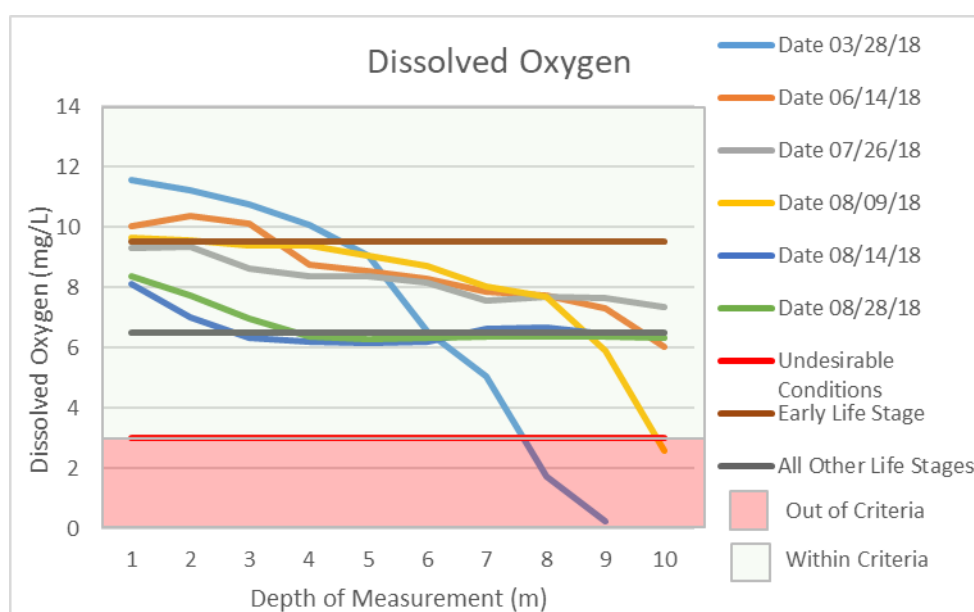
Figure 3: Dissolved oxygen in East Basin of Lac La Biche Lake - 2018

Dissolved oxygen levels in the East Basin of Lac La Biche Lake were recorded to a maximum depth of 9.5 m using multi-probe on March 28, June 14, July 18, July 26, August 9, August 14, and August 28, 2018. A maximum dissolved oxygen concentration of 11.56 mg/L was observed on March 28, 2018 at a depth of 1 m depth which declined to 0.01 mg/L at the lake bed (Figure 4). Average dissolved oxygen measurements over the sampling period was 7.47 mg/L.

In 2018, the dissolved oxygen data from East Basin indicated that the average dissolved oxygen levels for all sampling events ranged from 9.51 mg/L to 4.46 mg/L and were within proximity to the regulatory criteria for dissolved oxygen in cold water lakes (9.5 mg/L for early life stages and 6.5 mg/L for all other life stages).

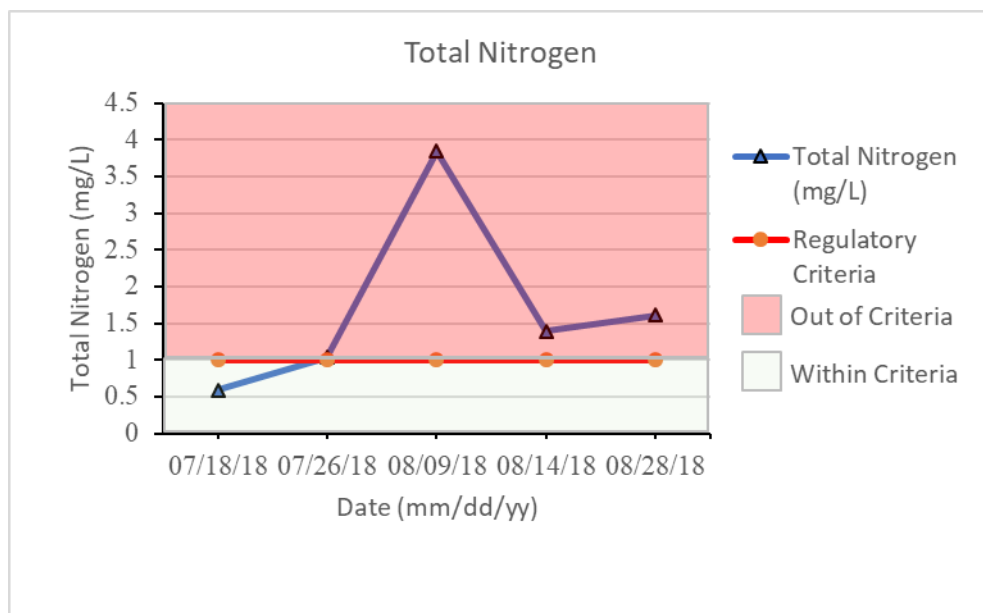
Figure 5: Total nitrogen from composite samples in East Basin of LLB Lake – 2018

Composite lake water samples for analyses of total nitrogen were collected on July 18, July 26, August 9, August 14, and August 28, 2018. The analytical results of these samples are presented in Figure 5. As indicated, the minimum total nitrogen concentration of 0.59 mg/L was noted in sample collected on July 18, 2018 which increased to a maximum concentration of 3.84 mg/L in a sample collected on August 9, 2018. However, the total nitrogen concentration declined again to 1.39 mg/L in a sample collected on August 14, 2018.

Nitrogen concentrations in the composite samples collected from the lake in 2018 had an average of 1.70 mg/L of total nitrogen which exceeded the applicable regulatory guidelines. The average total nitrogen indicates that the East Basin of Lac La Biche Lake is Hypereutrophic (excessive productivity, nutrients, and algae growth) based on total nitrogen from composite samples.

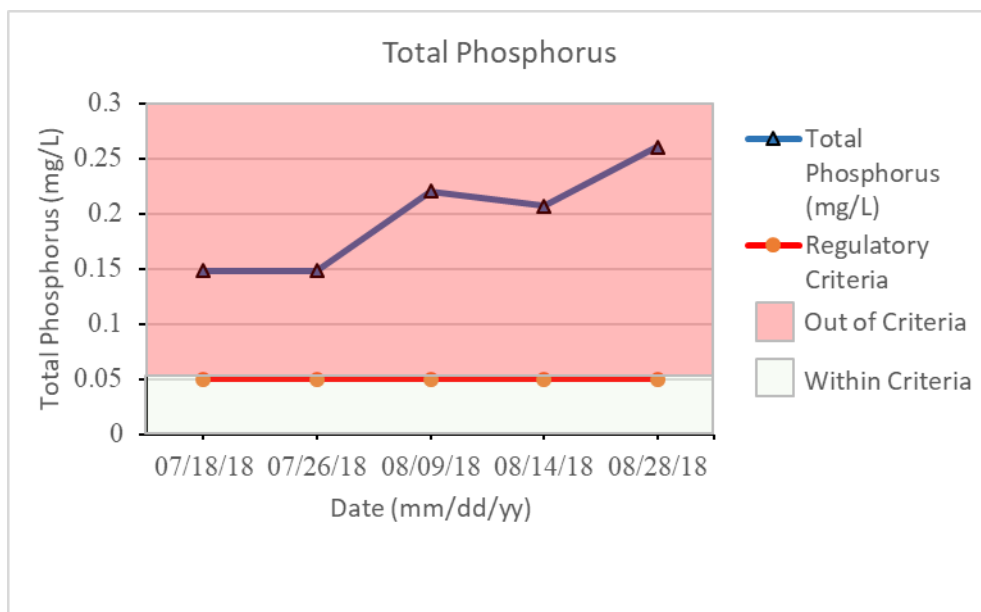
Figure 8: Total phosphorus from composite samples in East Basin of LLB Lake – 2018

Composite lake water samples for total phosphorous analysis were collected on July 18, July 26, August 9, August 14, and August 28, in 2018 from the East Basin in Lac La Biche Lake. The analytical results are presented in Figure 8.

Total phosphorous was 0.148mg/L in sample collected on July 18, 2018 which increased to 0.26 mg/L on August 28, 2018. Total phosphorous concentrations of all composite samples collected during 2018 exceeded the applicable regulatory guidelines (0.050 mg/L) with an average of 0.20 mg/L total phosphorus. This average total phosphorus concentration classifies the East Basin of Lac La Biche Lake as Hypereutrophic (excessive productivity, nutrients, and algae growth) based on total phosphorus from composite samples.

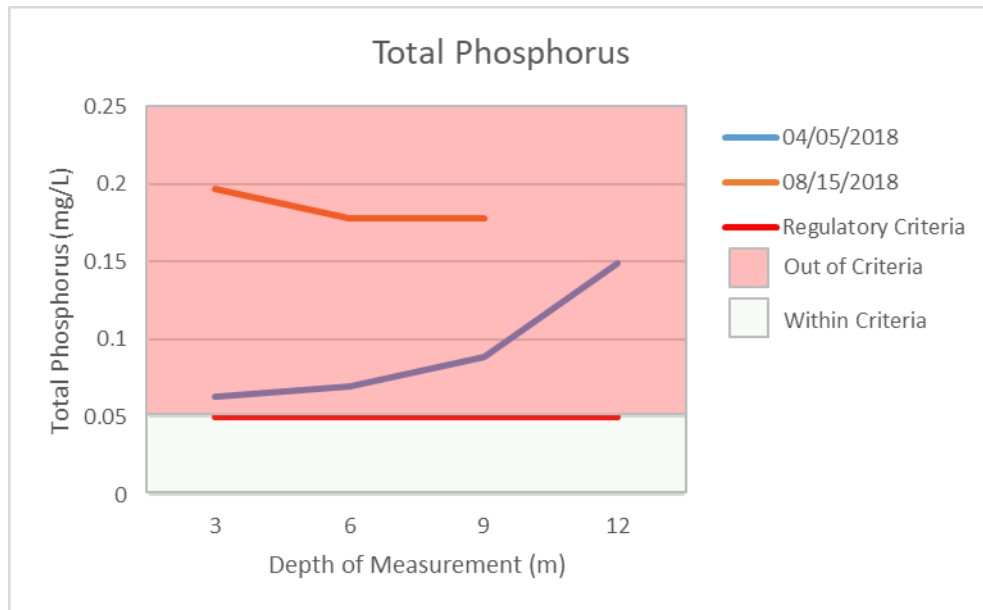
Figure 9: Total phosphorus from Kemmerer samples in East Basin of LLB Lake - 2018

Kemmerer water samples using Kemmerer sampling device were collected on April 5 and August 15, 2018 from depths of 3 m, 6 m, and 9 m and were analyzed for total phosphorous by ALS laboratories. The laboratory results are presented in Figure 9.

The total phosphorus concentration in lake water samples collected on August 15, 2018 were higher than the samples collected on March 5, 2018 at all depths. Total phosphorous concentrations in the samples collected on August 15 slightly decreased from the 3 m sampling depth (0.197 mg/L) to the 9 m sampling depth (0.178 mg/L). However, March 5 steadily increased through each depth, from 3 m (0.063 mg/L) to 12 m (0.149 mg/L). Total phosphorous in all samples collected from different depths on March 5 and August 15 exceeded the applicable regulatory guidelines with an average total phosphorus concentration of 0.13 mg/L. The results from the Kemmerer sampling resulted in the same trophic state classification as the composite samples which is Hypereutrophic (excessive productivity, nutrients, and algae growth) based on total phosphorus.

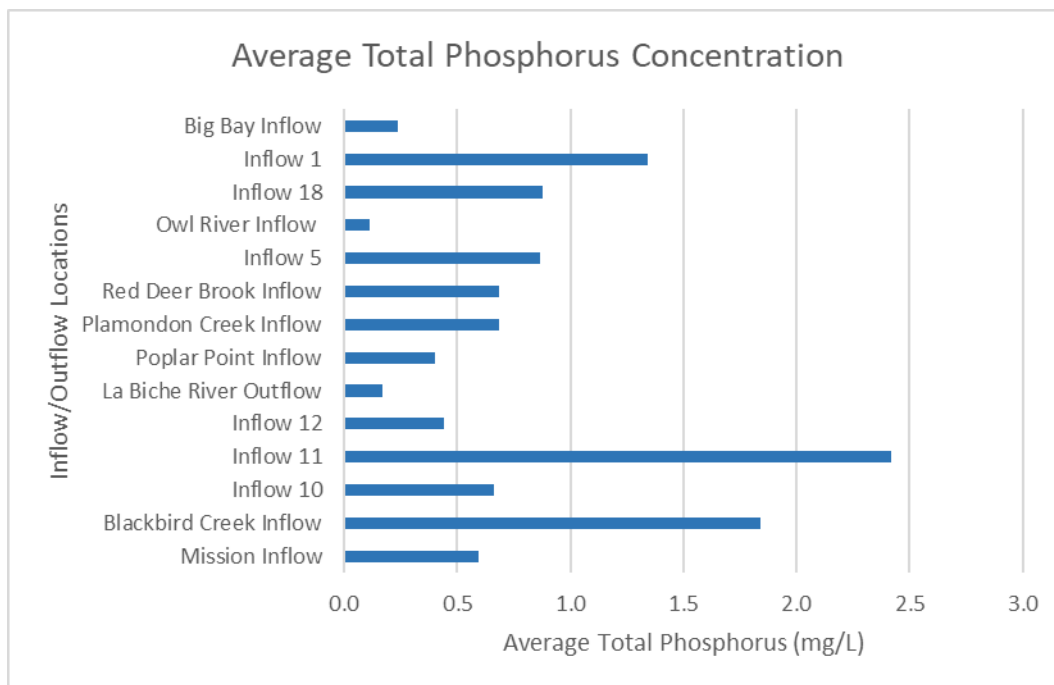
Figure 10: Inflow and outflow total phosphorous concentration for Lac La Biche Lake - 2018

The inflows and outflow for Lac La Biche Lake were collected on June 27, July 31, and August 27, 2018. Data regarding inflow total phosphorus concentrations is illustrated in Figure 10.

Total phosphorus concentrations in all of the inflow and outflow samples exceeded the applicable regulatory guideline 0.050 mg/L for total phosphorus concentration.

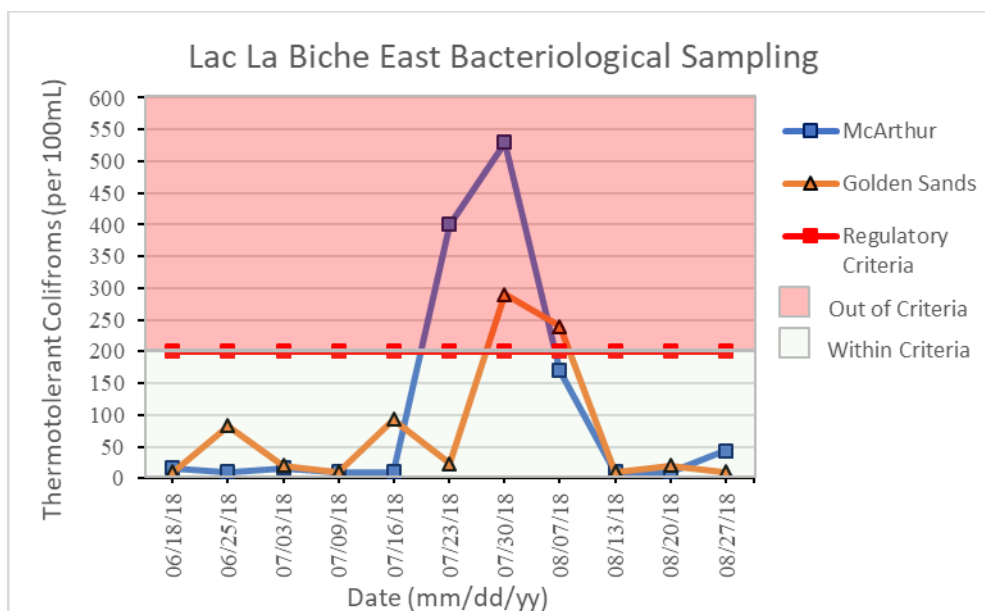
Figure 11: Thermotolerant coliform counts from beaches in East Basin of LLB Lake - 2018

In the East Basin of Lac La Biche Lake, the beaches at Golden Sands and McArthur Place were tested for thermotolerant coliforms on June 18, June 25, July 3, July 9, July 16, July 23, July 30, August 7, August 13, August 20, and August 27, 2018. Results of these samples are presented in Figure 11.

McArthur Place data regarding thermotolerant coliforms shows that two samples collected on July 23 and July 30, 2018 exceeded the regulatory guidelines with counts of 400 cfu/100 mL and 530 cfu/100 mL. Golden Sands data regarding thermotolerant coliforms shows that two samples collected on July 30 and August 7, 2018 exceeded the regulatory guidelines with counts of 290 cfu/100 mL and 240 cfu/100 mL. Additional sampling for thermotolerant coliform at these locations resulted in concentrations which were within the applicable guidelines.

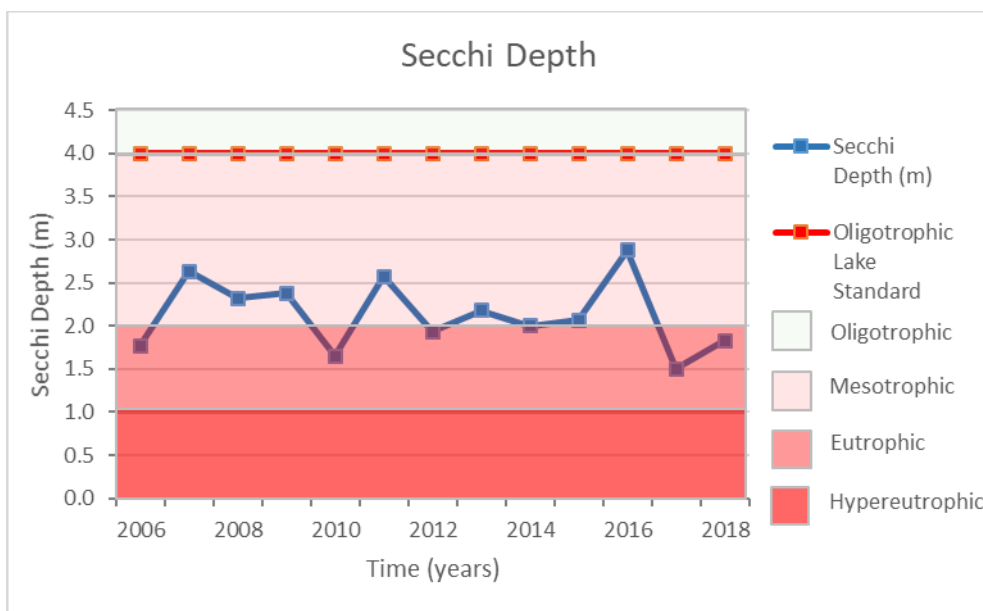
Figure 12: Historical trend for Secchi Depth in East Basin of Lac La Biche Lake

Historical data indicates that the Secchi depth in the East Basin of Lac La Biche Lake has historically been Mesotrophic (some productivity, nutrients, and algae growth) to Eutrophic (high productivity, nutrients, and algae growth) based on Secchi depth with little variation through the years. The secchi depth ranges from 1.5 m to 2.9 m and has been less than the standard Oligotrophic Secchi depth of 4 m as shown ever since the monitoring began in 2006 (Figure 12). The low average Secchi depth means that the lake water has poor transparency due to suspended materials. The Secchi depth readings however, may not provide an exact measure of the water transparency due to various errors such as time of the day, sun's glare on the water, and eyesight of the observer.

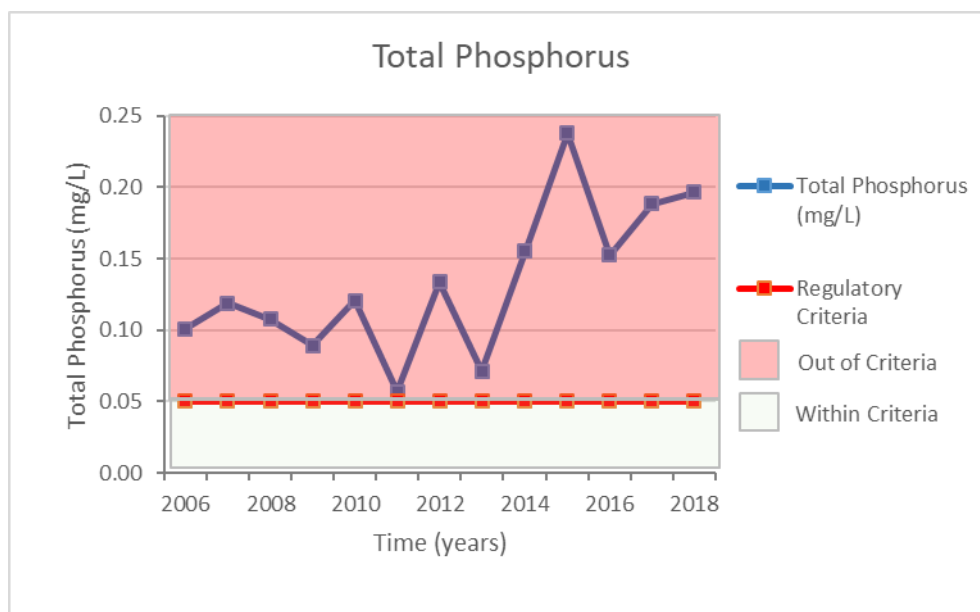
Figure 14: Historical trend of total phosphorus in East Basin of Lac La Biche Lake

Historical data shows that total phosphorus concentration in the East Basin of Lac La Biche Lake has ranged from 0.05 mg/L to 0.27 mg/L and has exceeded the regulatory criteria of 0.05 mg/L since 2006 as shown in Figure 14. Historical data shows that the East Basin of LLB Lake has been classified as Eutrophic (high productivity, nutrients, and algae growth) to Hypereutrophic (excessive productivity, nutrients, and algae growth) based on total phosphorus. A temporal increasing trend in total phosphorus concentration has been observed. The continuous increase of total phosphorus concentration in this lake is alarming and clearly shows that phosphorus loading in this lake is increasing over time.

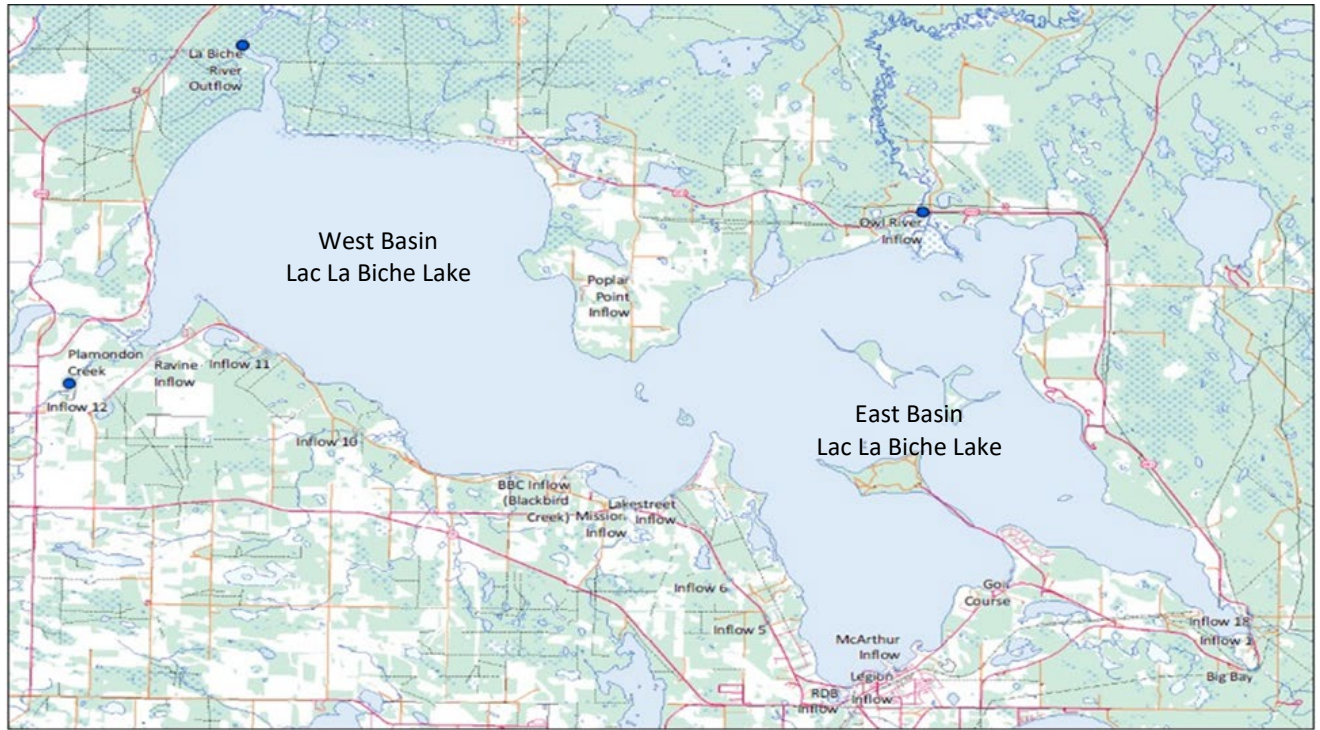
Figure 15: Map of Lac La Biche Lake with inflow/outflow locations

There are several small unnamed creeks located around the lake that flow into the East and West Basins. The main inflows into LLB Lake are Owl River, Red Deer Brook, Plamondon Creek and one unnamed creek which flows into the bay near the Lac La Biche Mission. All of these major inflows are located in the East Basin except for Plamondon Creek which is located in the West Basin. The only outflow for the lake is the La Biche River, which is located on the northwest shore of the West Basin.
